FIRE SAFETY FOLLOW UP INSPECTION

Factory Name	Impress-Newton Composite Textiles Limited		Factory ID	9514
Address	Gorai, Mirzapur, Tangail			
Initial Inspection Date	24-Jun-2014		Report Received Date	
Date of 1st Follow-up	29-Jul-2015	Date of 2nd Follow-up	18-Feb-2016	
Date of 3rd Follow-up	26-May-2016	Date of 4th Follow-up	21-Aug-2016	
Date of 5th Follow-up	15-Nov-2016	Date of 6th Follow-up	24-Jan-2017	
Date of 7th Follow-up	19-Apr-2017	Date of 8th Follow-up	06-Aug-2017	
Date of 9th Follow-up	15-Nov-2017	Date of 10th Follow-up	08-Jul-2018	
Date of 11th Follow-up	13-Dec-2018	Date of 12th Follow-up	18-Jul-2019	
Date of 13th Follow-up	07-Nov-2019	Date of 14th Follow-up	11-Oct-2020	
Date of 15th Follow-up	17-Jul-2022	Date of 16th Follow-up		
Date of 17th Follow-up		Date of 18th Follow-up		
Date of 19th Follow-up		Date of 20th Follow-up		
Inspected by	Md. Sadid Rahman

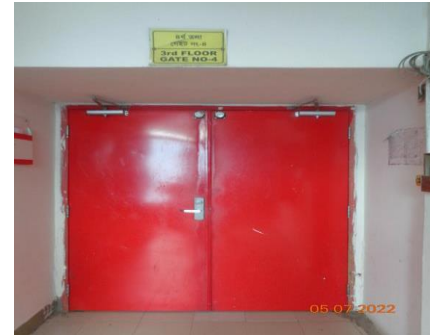
Item No	Inspection Observation	Inspection Recommendation	Timeline given	Comments after Physical Inspection	Supposed to complete(DD/MM/YYYY)	Final Action Plan (Factory)	Status on the date of Inspection	Pictorial Evidence
1	The exit stairs are not separated from work areas on each floor by fire-rated construction. Even though the fifth stair is not being counted as an exit stair it is still required to be separated like an exit stair since it is connecting four floors.	Provide minimum 1.5-hr fire rated doors and seal all unprotected openings to separate the exit stairs from work areas and other building spaces on all floor levels. Ensure that the fire doors are self-closing and positive latching and that they are provided with fire exit (panic) hardware where serving production floors. If fire doors are required to be held open for functional reasons, provide automaticclosing devices tied to the fire alarm system. Within 3 months F-1	Within 3 months	On 15/11/2017: Fire door installation has been done and interfacing work with FACP is on going. On 08/07/2018: Fire door installation has been done but door accessories & interface with FACP is not functional properly. Moreover, door kept open by external source. On 13/12/2018: Retrofitting work is going on and still need to proper fire rated separation. On 18/07/2019: Corrected. On 07/11/2019: Corrected. On 11/Oct/2020: Corrected. On 05-Jul-2022: Corrected as per previous follow ups. Note: Factory shall ensure that the fire rated doors have appropriate fire rating integrity. If required, factory shall replace the damaged door's hardware with new one. Unauthorized modification is not permitted.	18-May-2016	Corrected	Corrected

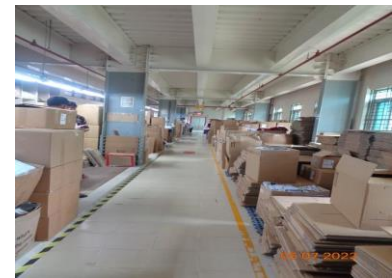
2	Areas used for combustible storage are not separated by fire-rated construction. Location: All floors.	Provide dedicated storage rooms separated by minimum 1-hr fire-rated construction. Where separate storage rooms are not feasible, provide defined storage areas and limit the storage arrangement as follows: - Maximum height of 2.4m and maximum area of 23m ² - If sprinkler protected: maximum height of 3.66m and maximum area of 93m ² Separate areas of unenclosed combustible storage by a minimum clear distance of 3m.	Within 3 months	On 19/04/2017: Corrected. Defined storage area has been maintained within limit. On 15/11/2017: Issue has been reopened at point no 26. On 08/07/2018: Issue has been reopened at point no 26. On 13/12/2018: Corrected. On 18/07/2019: Corrected as per previous follow up inspection. On 07/11/2019: Corrected. On 11/Oct/2020: Corrected. On 05-Jul-2022: Corrected as per previous follow up. Note: Factory shall ensure that, storage area has been maintained as per recommendation in 1st and 2nd floor of Building-1.	07-Aug-2015	Corrected	Corrected

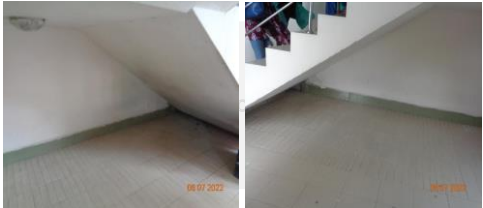
9	Storage was located in the exit stair. Fixed pump equipment was mounted under one of the stairs. Location: Several floors of all stairs, particularly, at ground floor.	Remove all storage from exit stairs and egress paths.	Immediate	On 15/11/2016: Corrected. On 24/01/2017: Corrected. On 15/11/2017: Corrected. On 08/07/2018: Corrected. On 13/12/2018: Corrected. . On 18/07/2019: Corrected. On 07/11/2019: Corrected. On 11/Oct/2020: Corrected. On 05-Jul-2022: Corrected.	10-Aug-2015	Corrected	Corrected

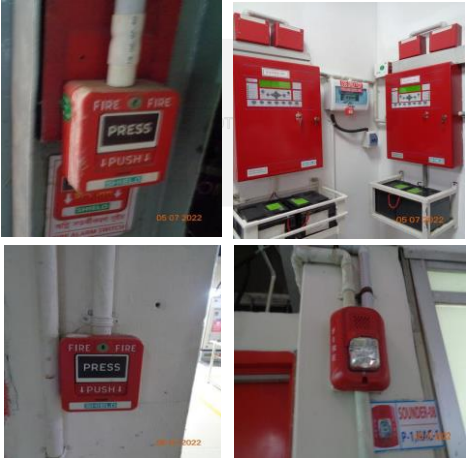
12	The fire alarm system is antiquated, not a listed system, and does not provide alarm and notification features consistent with acceptable standards.	Replace the fire alarm system with a new, listed addressable fire alarm system in accordance with NFPA 72.	Design within 4 months, install within 9 months	On 13/12/2018: Installation process almost completed and pending T&C. On 18/07/2019: Reportedly, installation completed. Awaiting for T&C. On 07/11/2019: T&C Documents Assessment Visit conducted and found documents & system is not ready for functional T&C VI. On 11/Oct/2020: T&C VI found that the system is not approved. See detailed T&VI report. On 18-Jan-2021: By Fire Safety Engineering Support Assistant (T&C), There is no documentation issues for this factory now. They need to keep the hard copies of a full set of corrected drawings & documents for both systems and need to wait for the schedule. On 19-09-2021(Completed on 11-10-2021): T&C VI found that final verification is required. See detail T&C VI report On 13-02-2022: FVI found that another final verification is required. See detail FVI report. On 16-05-2022: The system is corrected based on the last Final Verification Inspection (FVI). See detail FVI report. On 05-Jul-2022: Corrected on last final verification inspection. System has been found functional. Fire Rated door has been found interfaced with FADS properly.	18-May-2016	We have finished all the work related to Fire alarm system. Now we are waiting for T&C VI.	Corrected

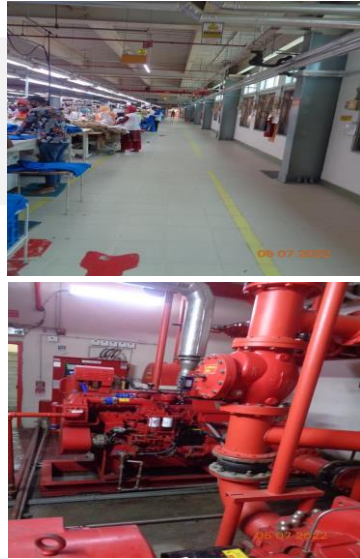
13	The building is not a high-rise building. However, it is of nonrated steel construction and has a floor area and number of stories exceeding ACCORD standards. The building is not provided with automatic sprinkler protection. The large occupant loads, heavy fuel loading, and anticipated extended egress times warrant sprinkler	Provide automatic sprinkler protection throughout the building in accordance with NFPA 13.	Design within 6 months, install within 12 months	On 15/11/2017: Installation process is on going. On 08/07/2018: Non listed fire pump will be replace by listed pump set. Factory informed already LC has been opened for listed pump set & necessary accessories. Wrong sprinkler system installation was observed. On 13/12/2018: Installation process almost completed and pending T&C. On 18/07/2019: Reportedly, installation completed. Awaiting for T&C. On 07/11/2019: T&C Documents Assessment Visit conducted and found documents & system is not ready for functional T&C VI. On 11/Oct/2020: T&C VI found that the system is not approved. See detailed T&VI report. On 18-Jan-2021: By Fire Safety Engineering Support Assistant (T&C), There is no documentation issues for this factory now. They need to keep the hard copies of a full set of corrected drawings & documents for both systems and need to wait for the schedule. On 19-09-2021(Completed on 11-10-2021): T&C VI found that final verification is required. See detail T&C VI report On 13-02-2022: FVI found that another final verification is required. See detail FVI report. On 16-05-2022: The system is corrected based on the last Final Verification Inspection (FVI). See detail FVI report. On 05-Jul-2022: Corrected on last final verification inspection. System has been found functional.	18-May-2016	We have finished all the work related to Sprinkler system. Now we are waiting for T&C VI.	Corrected
