Structural Safety Inspection Report

Factory Name	Impress Newtex Composite Textile Ltd
Factory ID	9514
Factory Address	Gorai, Mirzapur
Date of Initial Inspection	14-May-2014
Date of Review Inspection	09-Feb-2021
Inspected by	Abhishek Gain

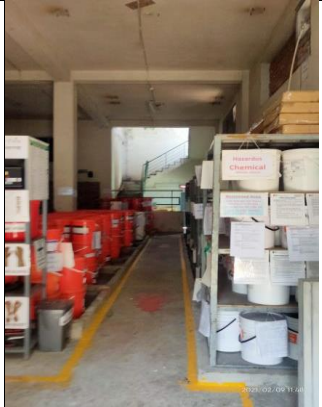
2	No fire proofing for steel structure elements	Maintain standard of quality control.	Within 6 months	Done	31-Jan-2016	<p>On 29/7/2015: Fire proofing material is not required for the existing steel structure.</p> <p>On 7/5/2017: Not Applicable.</p> <p>On 6/8/2017: Fire proofing materials is not required for existing structure. This issue remains</p> <p>On 12/03/2018: Fire proofing not required. This issue is corrected from previous follow-up.</p> <p>On 13-12-2018: The issue is corrected according to the previous inspection.</p> <p>On 6th Jan-2019: Corrected from previous inspection.</p> <p>On 23-Sep-2020: This issue is corrected in previous follow-up inspection.</p> <p>On 09-Feb-2021: N/A. This issue is corrected in previous follow-up inspection.</p>	Corrected	
3	Inconsistencies between the drawing of Building 2 and the actual as - built condition.	Factory Engineer to survey the actual condition and revise the drawings.	Dec 30 2014	We got DEA approval from Accord on 3rd october 2018 and we have already completed all retrofitting work in line with the said approval on 19th December 2018.	31-Jan-2016	<p>On 29/7/2015: This issue will be covered under DEA. The factory management submitted the DEA which is under review.</p> <p>On 7/5/2017: During inspection it was found that factory management was demolishing the building.</p> <p>On 6/8/2017: Factory engineer has produced as-built drawing as a part of DEA. The factory has got some review comments on the submitted DEA on 26-July-2017 and on the day of inspection, they told that they are working on the review comments. During inspection it was found that 1st floor of the building has been demolished except stair room portion. Factory shall have to submit revised DEA considering review comments as early as possible.</p> <p>On 12/03/2018: Factory engineer has produced as-built drawings as a part of DEA. Review comments on factory DEA were sent on 13th Jan 2018. Factory has submitted revised DEA on 5th Feb 2018 which is under review.</p> <p>On 13-12-2018: Factory prepared an as-built drawing with the DEA report and got acceptance on 3-10-2018 from Accord. During verification, the drawing was verified on site and found match with as-built condition.</p> <p>On 6th Jan-2019: Corrected from previous inspection.</p> <p>On 23-Sep-2020: This issue is corrected in previous follow-up inspection.</p> <p>On 09-Feb-2021: This issue is corrected in previous follow-up inspection.</p>	Corrected

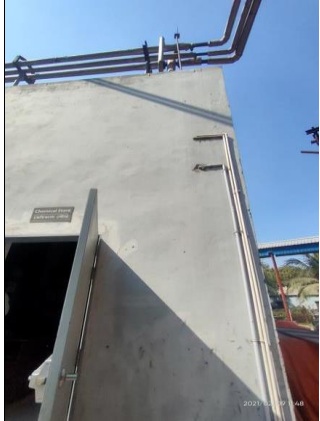
Item No	Inspection Observation	Action Plan from Inspection (Recommendation)	Timeline from Inspection	Final Action Plan from Factory	Final Timeline (dd-mmm-yyyy)	Comments after Physical Inspection	Progress Status	Pictorial Evidence
4	Inconsistencies between the drawing of Building 2 and the actual as - built condition.	Factory Engineer to review design, loads and columns stresses to confirm suitability for loads applied.	Dec 30 2014	We got DEA approval from Accord on 3rd October 2018 and we have already completed all retrofitting work in line with the said approval on 19th December 2018.	31-Jan-2016	<p>On 29/7/2015:This issue will be covered under DEA. The factory management submitted the DEA which is under review.</p> <p>On 7/5/2017: During inspection it was found that factory management was demolishing the building.</p> <p>On 6/8/2017: Factory engineer had reviewed the column stress as a part of DEA. The factory has got some review comments on the submitted DEA and on the day of inspection, they told that they are working on the review comments. Factory shall have to submit revised DEA considering review comments as early as possible.</p> <p>On 12/03/2018: Factory engineer has produced as-built drawings as a part of DEA. Review comments on factory DEA were sent on 13th Jan 2018. Factory has submitted revised DEA on 5th Feb 2018 which is under review.</p> <p>On 13-12-2018: Factory demolished 1st floor and reviewed the design for the existing single storey building and got acceptance on 3-10-2018 from Accord with retrofitting recommendation of shed on staircase. During inspection, the retrofitting was checked and found matched with approved retrofitting drawing.</p> <p>On 6th Jan-2019: Corrected from previous inspection.</p> <p>On 23-Sep-2020: This issue is corrected in previous follow-up inspection.</p> <p>On 09-Feb-2021: Corrected in previous follow-up inspection. This issue is covered in DEA and DEA got acceptance from Accord on 3-10-2018. Factory authority completed all the remediation work as per approved DEA.</p>	Corrected

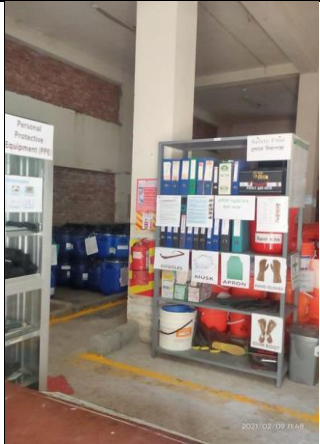
5	Inconsistencies between the drawing of Building 2 and the actual as - built condition.	Produce and actively manage a loading plan for all floor plates within this area giving consideration to floor capacity and column capacity.	Dec 30 2014	We got DEA approval from Accord on 3rd October 2018 and we have already completed all retrofitting work in line with the said approval on 19th December 2018.	31-Jan-2016	<p>On 29/7/2015:This issue will be covered under DEA. The factory management submitted the DEA which is under review.</p> <p>On 7/5/2017: During inspection it was found that factory management was demolishing the building.</p> <p>On 6/8/2017: During inspection it was found that 1st floor of building has been demolished except stair room portion. However, factory produced load plan for the ground floor along with DEA report. Factory shall have to submit revised DEA considering review comments as early as possible.</p> <p>On 12/03/2018: During inspection the first floor was found demolished. Factory engineer has produced ground floor load plan as a part of DEA. Review comments on factory DEA were sent on 13th Jan 2018. Factory has submitted revised DEA on 5th Feb 2018 which is under review.</p> <p>On 13-12-2018: Factory prepared a load plan with the DEA report and got acceptance on 3-10-2018 from Accord. The load plan was posted on ground floor and load was found within 42 psf as per approved load plan.</p> <p>On 6th Jan-2019: Corrected from previous inspection. Load plan has been produced and accepted as a part of DEA. During inspection accepted load plan was found posted at every floor and load was found below the allowable limit.</p> <p>On 23-Sep-2020: This issue is corrected in previous follow-up inspection.</p> <p>On 09-Feb-2021: This issue is corrected in previous follow-up inspection. Load was found below 42psf.</p>	Corrected

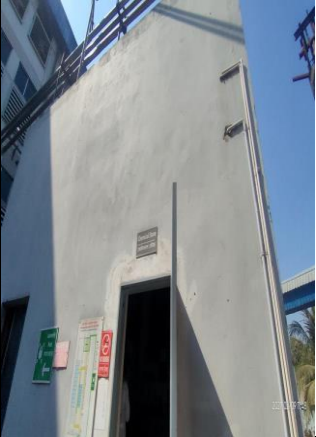
Item No	Inspection Observation	Action Plan from Inspection (Recommendation)	Timeline from Inspection	Final Action Plan from Factory	Final Timeline (dd-mmm-yyyy)	Comments after Physical Inspection	Progress Status	Pictorial Evidence
6	Inconsistencies between the drawings of Building 2 and the actual as-built conditions.	Continue to implement load plan	Within 6 months	We got DEA approval from Accord on 3rd October 2018 and we have already completed all retrofitting work in line with the said approval on 19th December 2018.	31-Jan-2016	<p>On 29/7/2015:This issue will be covered under DEA. The factory management submitted the DEA which is under review.</p> <p>On 7/5/2017:This issue will be covered under DEA. The factory management submitted the DEA which is under review. During inspection it was found that factory management was demolishing the building.</p> <p>On 6/8/2017: During inspection it was found that 1st floor of building has been demolished except stair room portion. However, factory produced load plan for the ground floor along with DEA report. Factory shall have to submit revised DEA considering review comments as early as possible.</p> <p>On 12/03/2018: During inspection the first floor was found demolished. Factory engineer has produced ground floor load plan as a part of DEA. Review comments on factory DEA were sent on 13th Jan 2018. Factory has submitted revised DEA on 5th Feb 2018 which is under review.</p> <p>On 13-12-2018: Factory prepared a load plan with the DEA report and got acceptance on 3-10-2018 from Accord. The load plan was posted on ground floor and load was found within 42 psf as per approved load plan.</p> <p>On 6th Jan-2019: Corrected from previous inspection. During inspection accepted load plan was found posted at every floor and load was found below the allowable limit.</p> <p>On 23-Sep-2020: This issue is corrected in previous follow-up inspection.</p> <p>On 09-Feb-2021: This issue is corrected in previous follow-up inspection. Building-2 2nd storey was demolished. At present, the building is single storied.</p>	Corrected

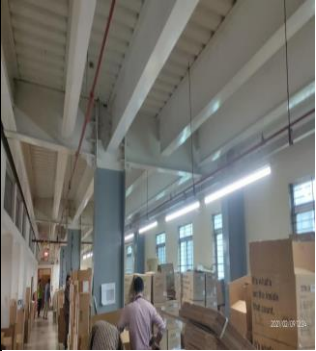
Item No	Inspection Observation	Action Plan from Inspection (Recommendation)	Timeline from Inspection	Final Action Plan from Factory	Final Timeline (dd-mmm-yyyy)	Comments after Physical Inspection	Progress Status	Pictorial Evidence
14	New finding # 4: Factory Engineer is required to review design, loads and stresses in all columns & foundations for the newly constructed 4-storied building adjacent with the Building-1	Engage a qualified structural engineer to confirm structural performance of the structure to comply with BNBC code and produce & actively manage a loading plan for all floor plates.	(within 6 – weeks)	Corrected. Detailed Engineering Assessment (DEA) has been reviewed & re-accepted by RSC on 21/11/2020. As per the approval, no retrofitting is required for the Extension part of Building-1.	24-Jan-2019	<p>On 13-12-2018: During inspection, a newly 4-storied building was observed which is east side of the Building-1 and connected with Building-1 with movement joint. The building is currently using for production purposes. Factory is required to engage a qualified engineer for assessing the structural performance and submit to Accord.</p> <p>On 6th Jan-2019: Factory has not submitted the EA of the new building yet. Factory is required to submit the EA of the building.</p> <p>On 23-Sep-2020: EA got acceptance by RSC on 16 Jul 2020. During EA verification, mismatches were found between accepted drawings and actual site condition. Flange thickness of all steel columns of the 2nd floor was not matched(5mm less than drawing) with as built drawings. Factory is required to update the drawings and FEM and submit to RSC within 2 weeks after receiving this report.</p> <p>On 09-Feb-2021: Factory submitted revised documents as per discrepancies found in verification inspection and got re-acceptance from RSC on 21st Nov 2020. No discrepancy was found during verification. No remediation was required.</p>	Corrected
